Addendum One West Bolivar Consolidated School District ESSER – Phase 2 Rosedale, Mississippi

SECTION 009113 - ADDENDUM ONE

- A. Project Name: 21034.01 West Bolivar Consolidated School District ESSER Phase 2.
- B. Owner: West Bolivar Consolidated School District, 909 Hwy 8, Rosedale, MS 38769.
- C. Architect: Dale | Bailey Architects, An Association, One Jackson Place. Suite 250, 188 East Capitol Street, Jackson, MS 39201.
- D. Architect Project Number: 21034.01
- E. Date of Addendum One: 29 June 2023

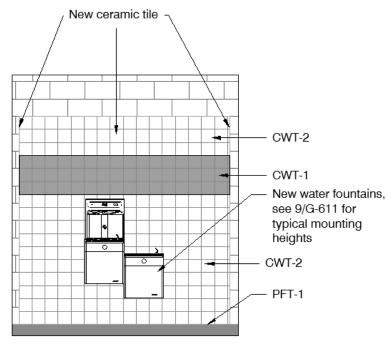
A. SHEET G-611 – GENERAL FINISH & DOOR DETAILS. (Not Re-Issued). Add the following:

- 1. Lay new ceramic wall tile on all 3 sides of inset for drinking fountain.
- 2. Contractor shall install Schluter into corners and edges of ceramic wall tile.
- Replace Detail 6 with new; see below:

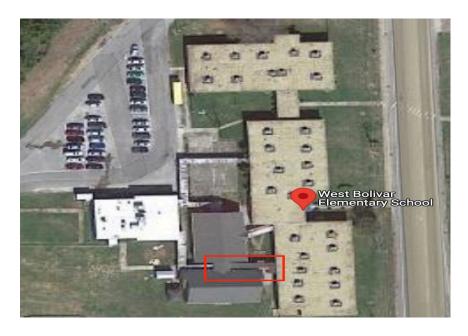
- 6 Typical Water Fountain Elevation
- B. SHEET A1-021 West Bolivar Elementary Roof Plan (Not Re-Issued).
 - 1. Add canopy as indicated below to reroofing scope of work. Existing canopy is approximately 53'-0" x 7'-0".
 - 2. Contractor shall remove any loose paint under the two canopies that will be reroofed and paint the canopies' fascia, soffit and columns.

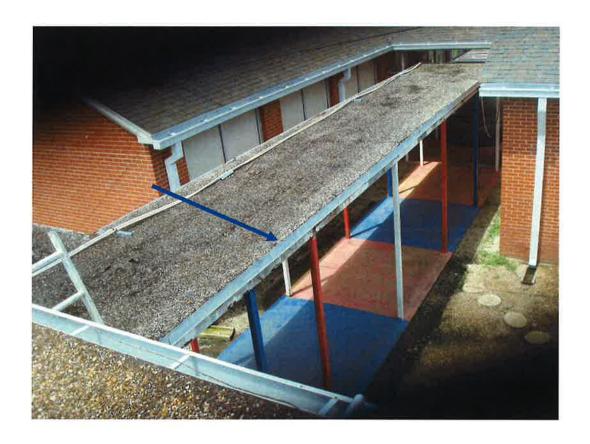
Roof Perimeter Flashing Homogeneous Area (HA) (123-07). This material is located along the perimeter the walkway roof. Material and sample locations are shown in Appendix 4.2. Laboratory analysis revealed that this material contains approximately 15% chrysotile asbestos in the adhesive. This material is in fair condition and is classified as a is classified as category I, non-friable ACMs according to National Emission Standards for Hazardous Air Pollutants (NESHAP) regulations.

Considering these findings, EPA's NESHAP 40 CFR 61, Subpart M, and the MDEQ title 11 Mississippi Administrative Code, Part 2, Chapter 1 requires the removal of ACM before any renovation or demolition takes place that will disturb those materials and render them friable.

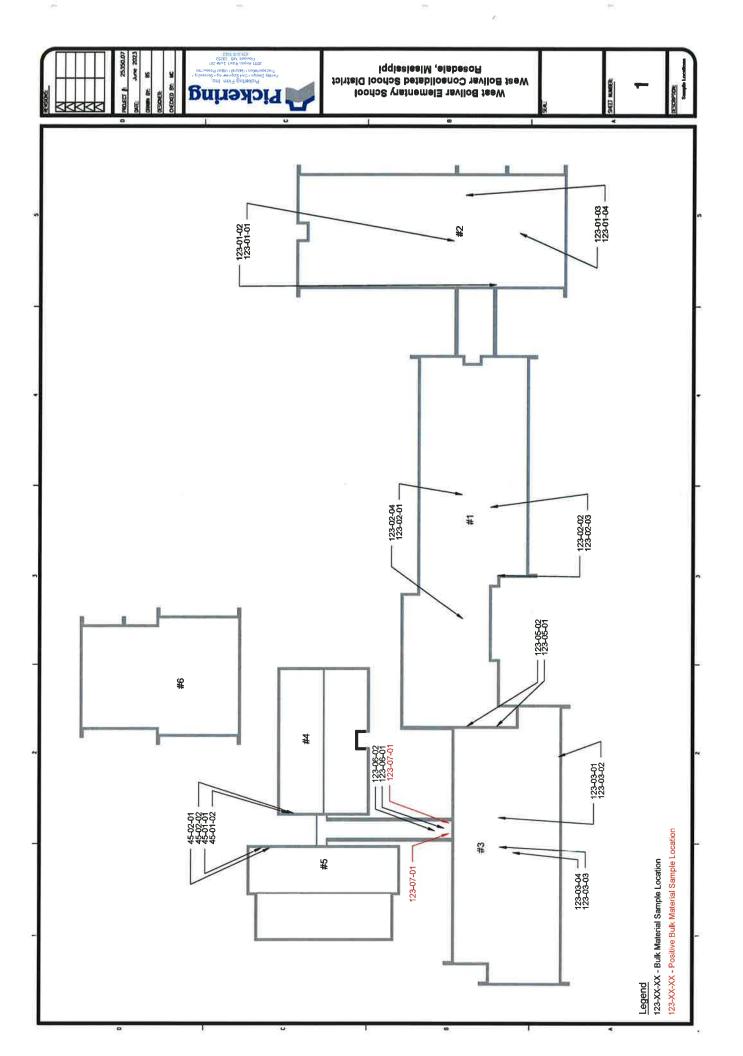
APPENDIX 4.2 Sample Locations Drawing

During our inspection activities, the locations of all samples collected were charted on a floor plan of the building. The sample location drawing is included in Appendix 4.2 - Sample Locations Drawing. Photographs of sampled materials are included in Appendix 4.3 - Photo Log.

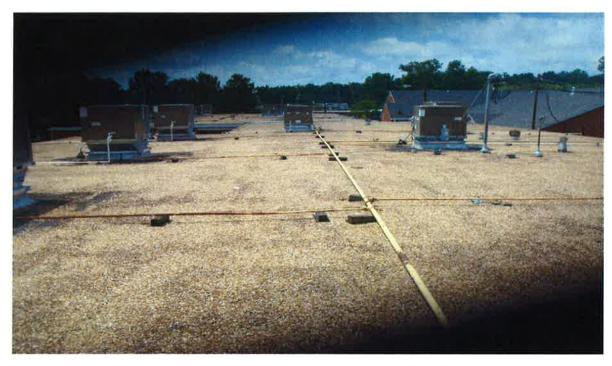
Built Up Roof Homogenous Area (HA) (123-01)

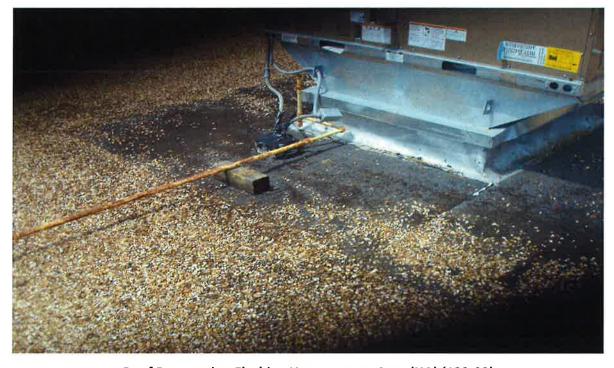
Roof Penetration Flashing Homogenous Area (HA) (123-03)

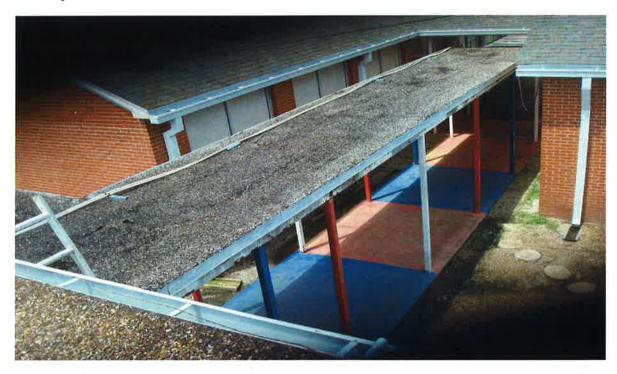
Built Up Roofing Homogenous Area (HA) (123-06)
Roof Perimeter Homogenous Area (HA) (123-07)

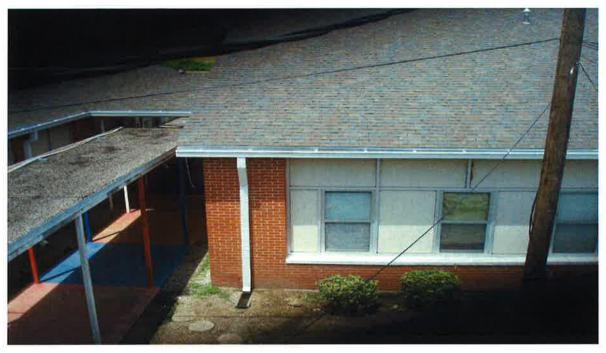
Roof Single Homogenous Area (HA) (45-01)
Roof Felt Homogenous Area (HA) (45-02)

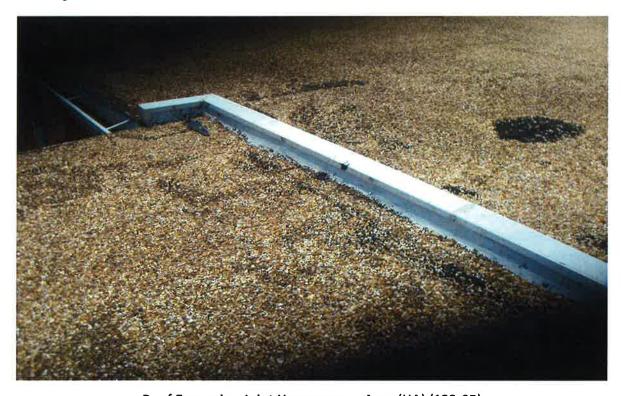
Roof Expansion Joint Homogenous Area (HA) (123-05)

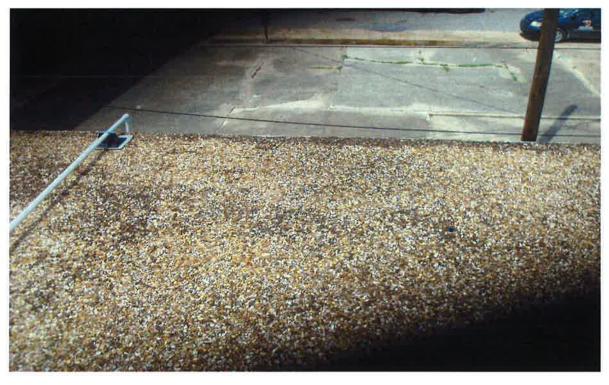
Roofing Perimeter Homogenous Area (HA) (123-02)

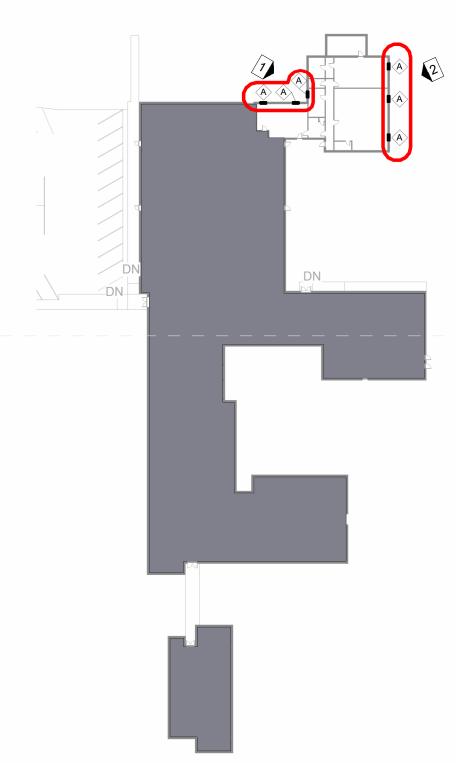
Window Replacement Notes

1. Contractor shall replace existing windows (6) located at West Bolivar High School with new single-hung windows.
